H RUTH TODD, AIA
A R C H I T E C T

Regarding: 353 N. Claremont Street

The purpose of this letter is to outline to you the issues involved with the repair and rehabilitation of the house located at 353 N. Claremont Street in San Mateo. It is my opinion that the following scope of work meets the Secretary of the Interior's Standards for Rehabilitation and presents no adverse affect on the historic property, so long as work is carried out in accordance with the outlined scope. Enclosed are photographs which will help to illustrate the proposed work.

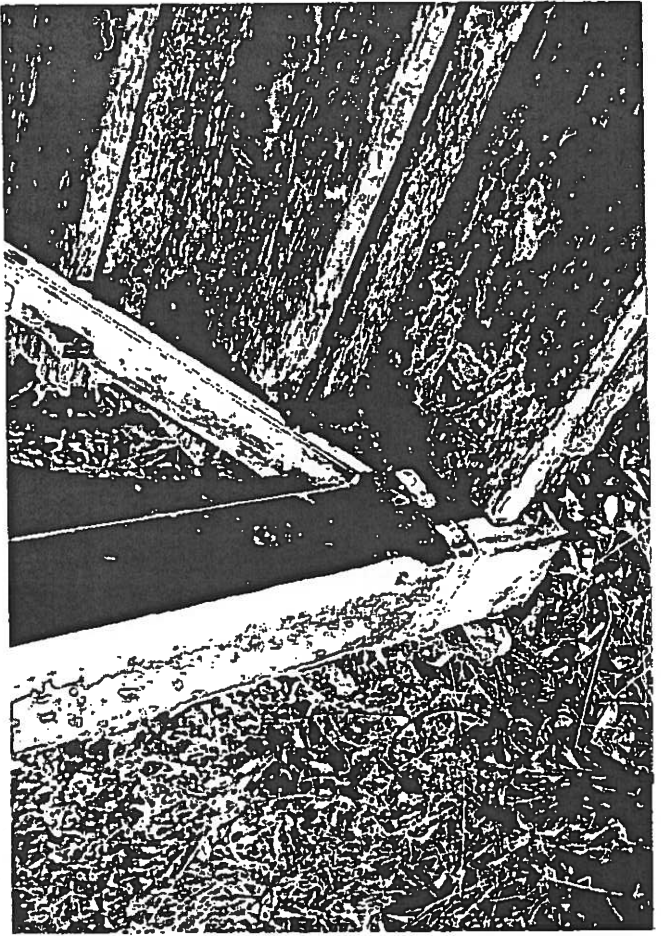
4

4. The existing newel posts appear to be original, but have been modified at the bottom, and a steel angle has been attached to one side. Remove the steel angle, and patch and repair all holes. Remove the newer portion of bottom posts and reconstruct new sections which provide a snug joint with the original newel posts. Provide an epoxied dowel connection if necessary for structural support.

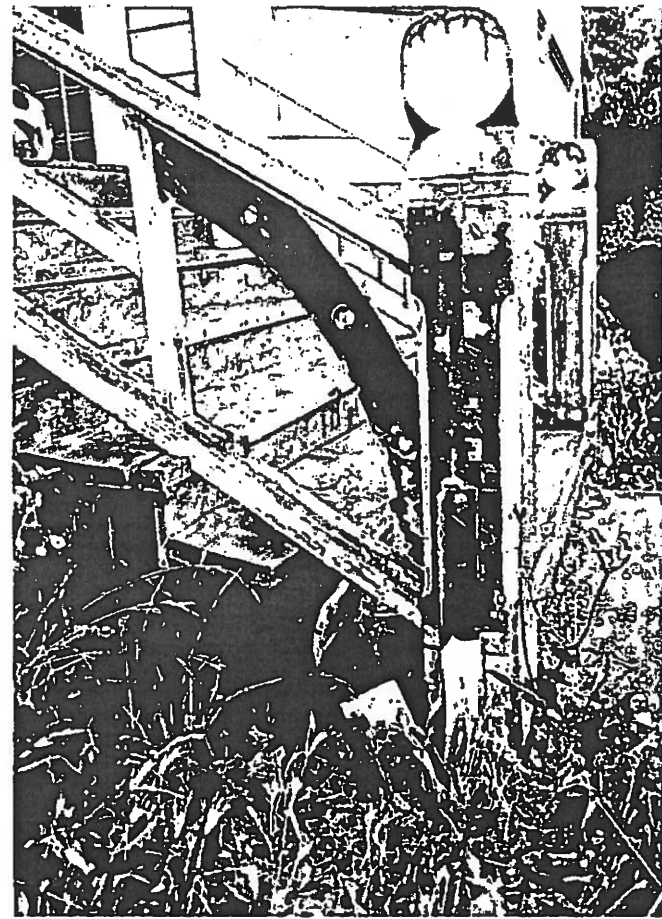
2

2. Remove rotted risers and treads and replace in kind. Notches in existing treads indicate that the original steps have been replaced. New treads and risers should be detailed to relate to the angle of the bottom rail so that the new treads do not need to be notched.

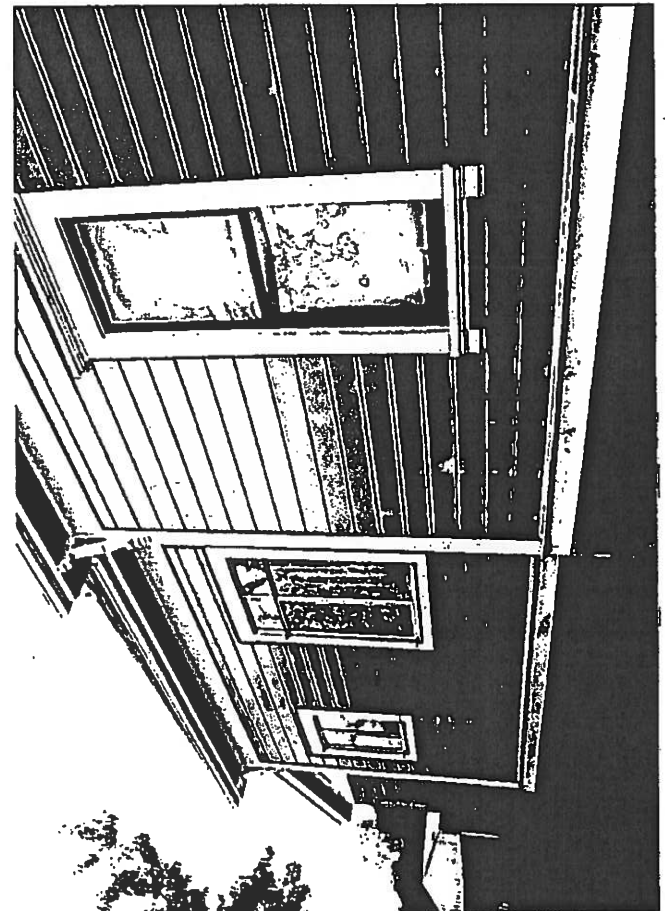
8

8. Remove aluminum sash from the larger of the side window openings. Install new operable 1/1 wood sash of a profile to match existing original sash. Leave existing trim in place. (It is my opinion that a pair of windows were originally located in the center of this wall, and were replaced with the existing configuration at a much later date.)

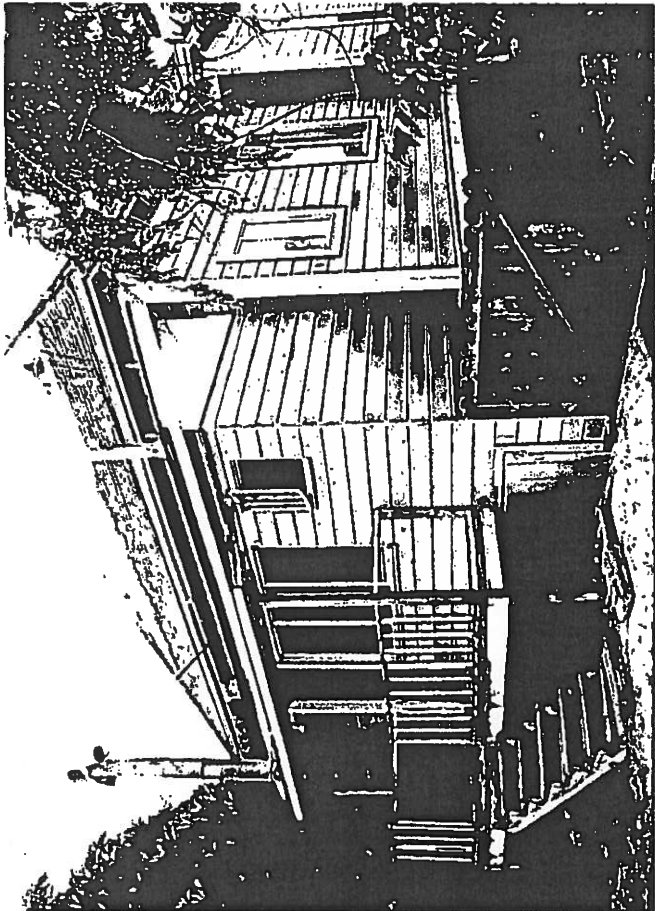
5

5. The entire rear porch and deck is a later addition to the original structure. Remove existing rotted deck and reconstruct a new wooden deck and stairs. New construction will be unroofed and compatible with the historic character of the house.

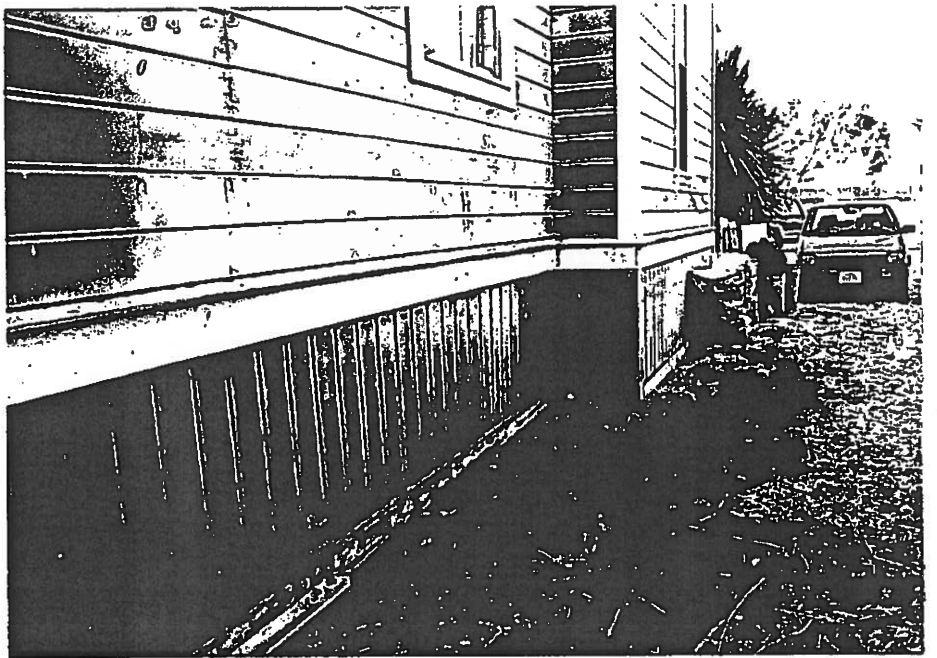
10

10. Existing drainage at the south side of the house currently drains toward the wood-finished wall. This is an undesirable situation which should be alleviated. My suggestion is to regrade the unpaved drive-way to allow for drainage away from

the house rather than toward it. The installation of a French drain under a gravel base would also be very beneficial. A complete survey of the perimeter of the house should be conducted and poor drainage areas reworked for positive drainage away from the residence.
