WOOD DESTROYING PESTS AND ORGANISMS INSPECTION REPORT

BUILDING NO. 353	STREET, CITY, STATE, ZIP N. Claremont St., San Mateo CA 94401	Date of Inspection 7/6/2010	No. of Pages 4
----------------------------	---	---------------------------------------	--------------------------

COMPLETE REPORT <input type="checkbox"/>	LIMITED REPORT <input checked="" type="checkbox"/>	SUPPLEMENTAL REPORT <input type="checkbox"/>	REINSPECTION REPORT <input type="checkbox"/>
General Description: single family residence, vacant, wood siding, composition roof		Inspection Tag Posted: exterior	
		Other Inspection Tags: Hastie Termite 06/03/10	
An inspection has been made to the structure(s) shown on the diagram in accordance with the Structural Pest Control Act. Detached porches, detached steps, detached decks and any other structures not on the diagram were not inspected.			
Subterranean Termites <input type="checkbox"/> Drywood Termites <input checked="" type="checkbox"/> Fungus/Dryrot <input type="checkbox"/> Other Findings <input type="checkbox"/> Further Inspection <input type="checkbox"/>			
If any of above boxes are checked, it indicates that there were visible problems in accessible areas. Read th

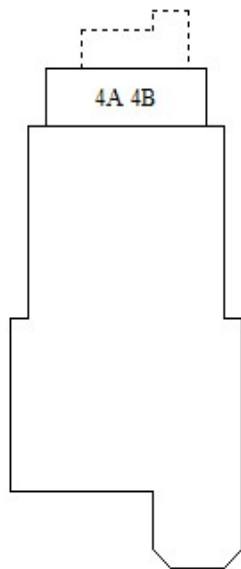
diagram not to scale

ITEM 4A Evidence of drywood termite infestation was noted in the subarea wood framing.

ITEM 4B Evidence of drywood termite infestation was noted as per item 4B.

CORRECTION: Fumigate the entire structure with Vikane (Sulfuryl Flouride with Chloropicrin warning agent) for complete eradication of all drywood termites in the entire structure.

CORRECTION: Treat drywood termites as recommended. Mask or cover drywood fecal pellets.
